Hopewell Area School District

Facilities Assessments at:

VEBH Project No. 180700

Preliminary Report (Phase 1) Board Presentation – April 8, 2019

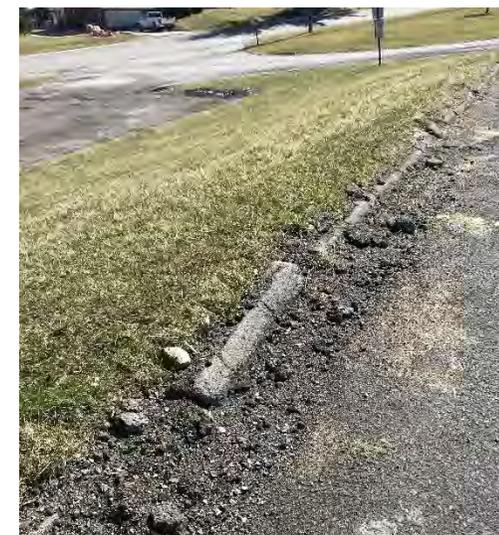
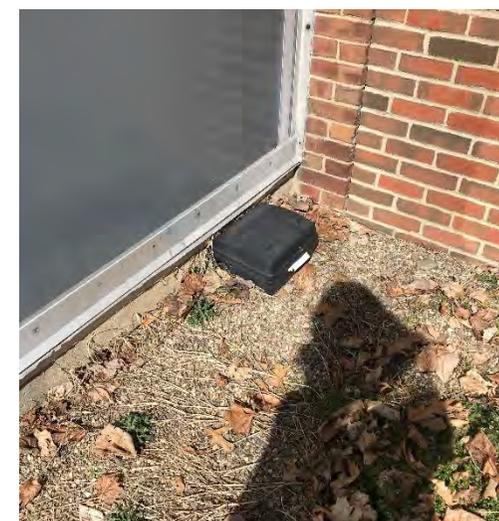
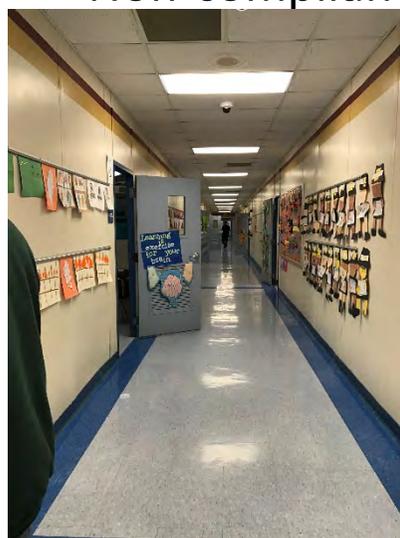
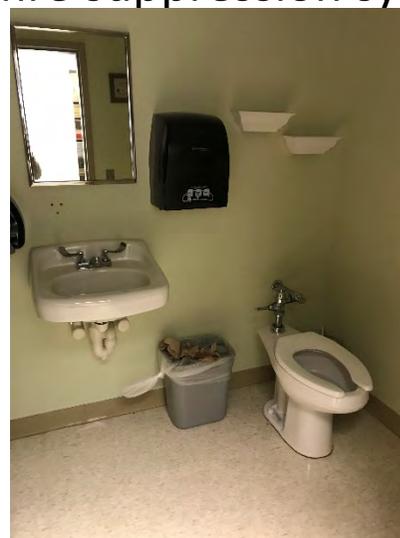
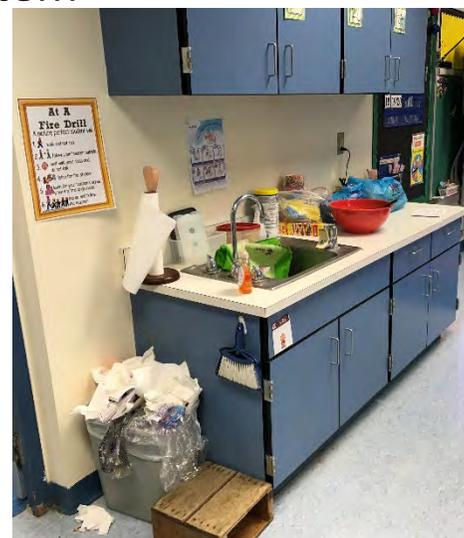
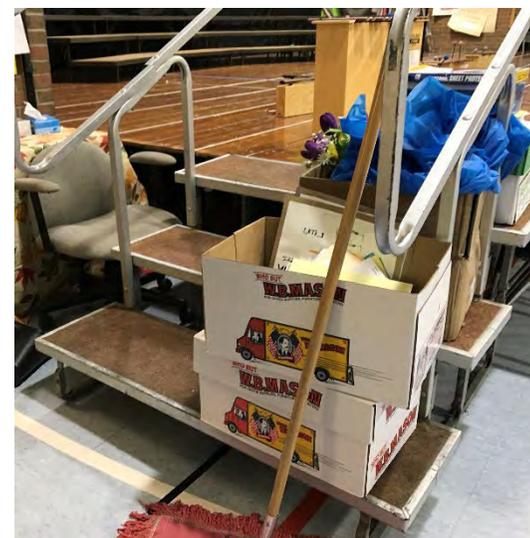
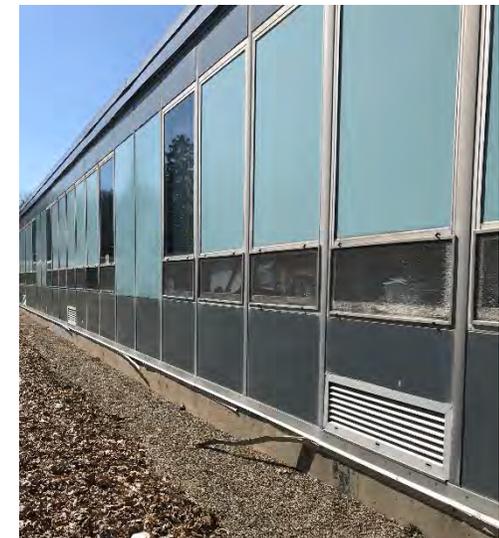
- Replace corridor / classroom prefabricated wall system (*non-rated*)
- Replace non-accessible sinks in classrooms, library, nurse, etc.
- Provide accessible access to platform in Multi-Purpose Room

- Repair portions of roof (*small portion needs replaced entirely*)
- Replace classroom wing windows (original to building – 1959)
- Interior door replacement (*classroom wing doors are original to the building*)
- Replace outdated chalkboards with marker boards
- Bus drive asphalt repairs / parking lot pavement repairs; restriping
- Rodent control

- Last equipment replacement was part of 1998 renovations (*20+ years*)
- Non-compliant fire suppression system

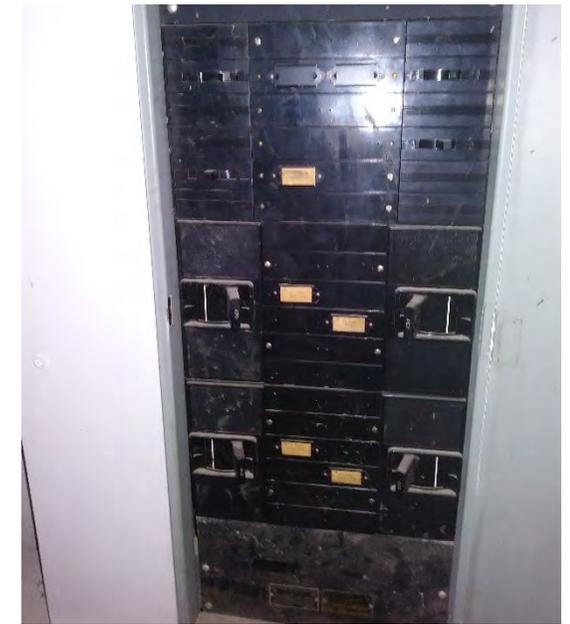
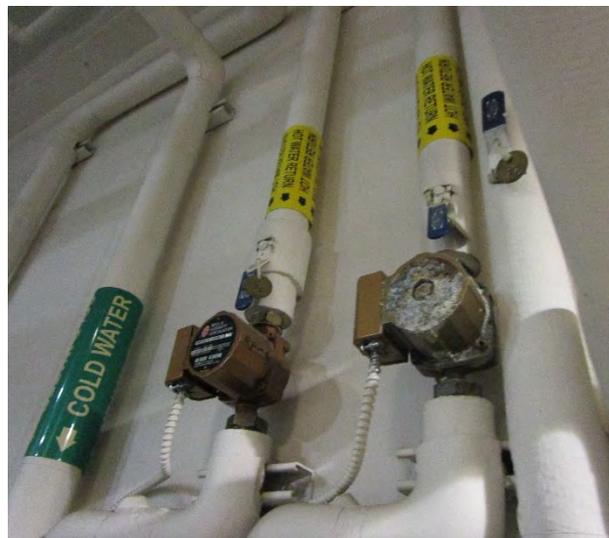
- **Plumbing infrastructure has reached end of functional life**
 - Water service entrance , valves, and piping
 - Water distribution piping is original to the building (*life expectancy is 50 years*)
 - Sanitary and storm piping is original to the building
 - Secondary (emergency) roof drainage
- **HVAC equipment has reached beyond the end of functional life**
 - Classroom unit ventilators, rooftop equipment
 - Pneumatic temperature control system is beyond expected life and difficult to maintain
- **Electrical Equipment has reached end of functional life**
 - Power distribution, lighting, intercom system, public address system, etc.
 - Fire alarm system is obsolete

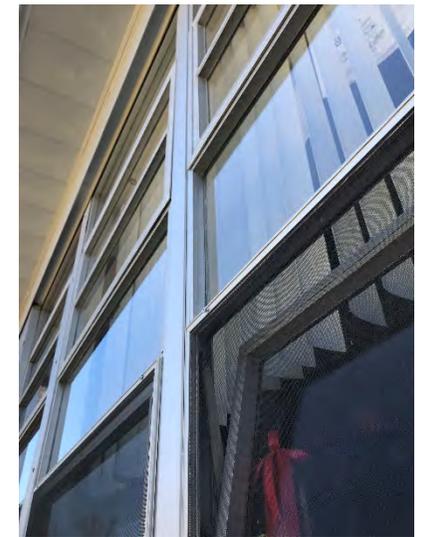
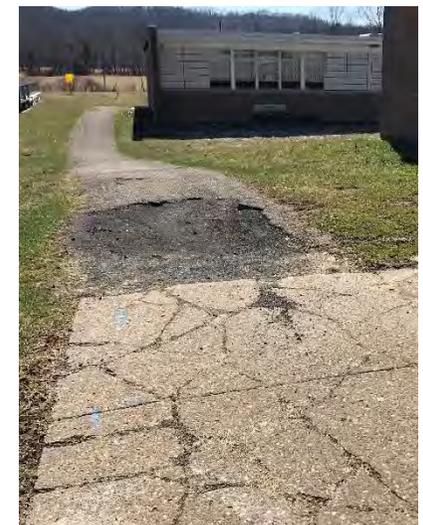
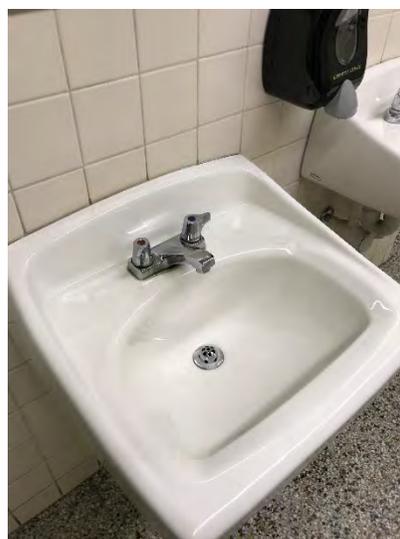
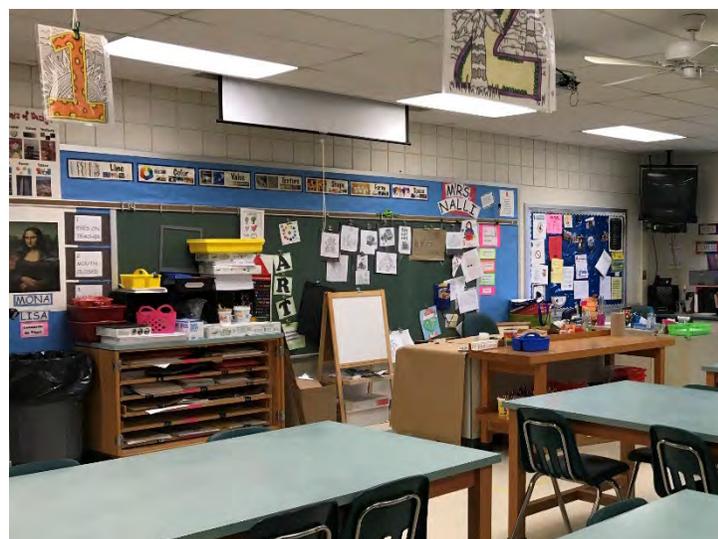
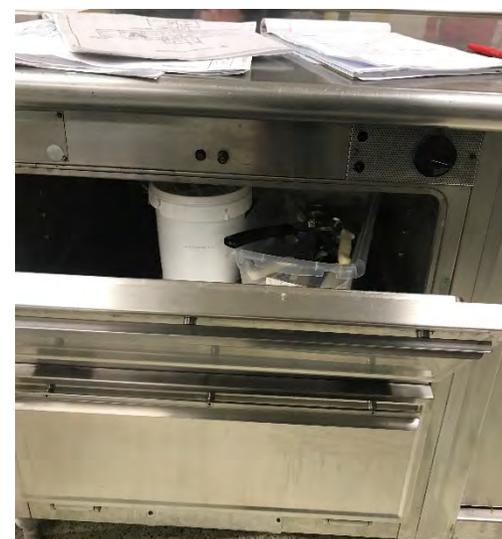
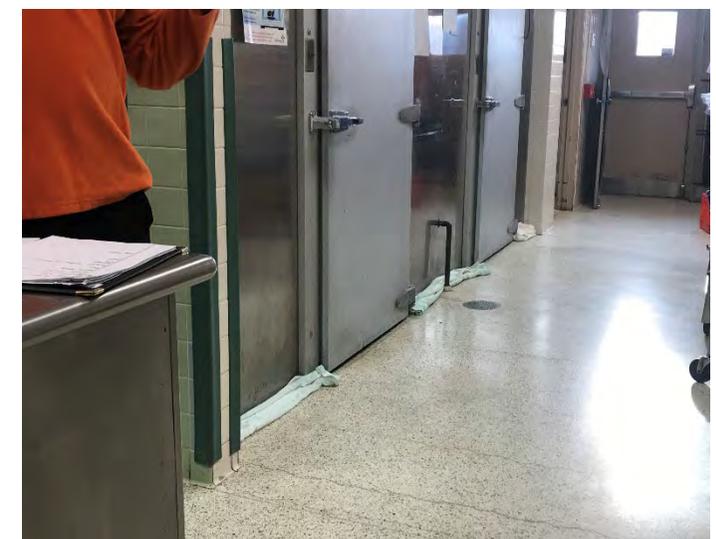
- Replace non-accessible sinks classrooms, library, nurse, etc.
- Replace non-accessible sink faucets in restrooms

- Repair portions of roof (*small portion needs replaced entirely*)
- Interior door replacement (*classroom wing doors are original to the building - 1960*)
- Replace exterior windows not replaced in 1998 renovations (original to building)
- Deteriorated sidewalks

- Last equipment replacement was part of 1998 renovations (*20+ years*)
- Non-compliant fire suppression system
- Lack of designated hand washing sinks
- Slightly oversized, inefficient relationship between kitchen and dishwashing

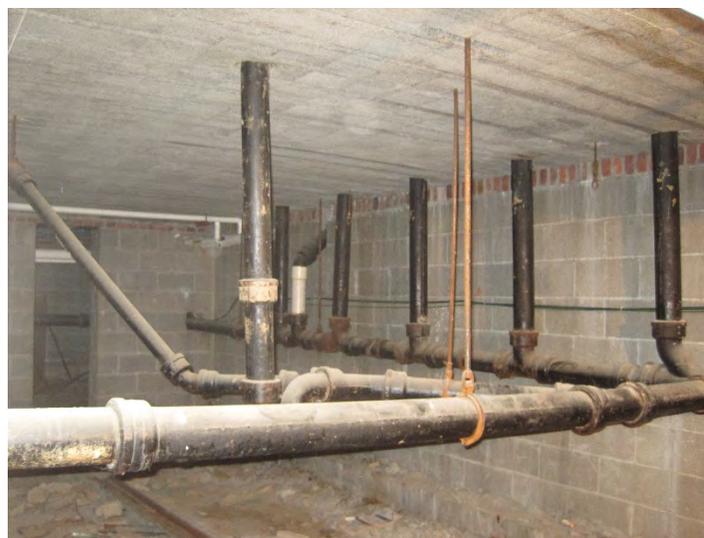
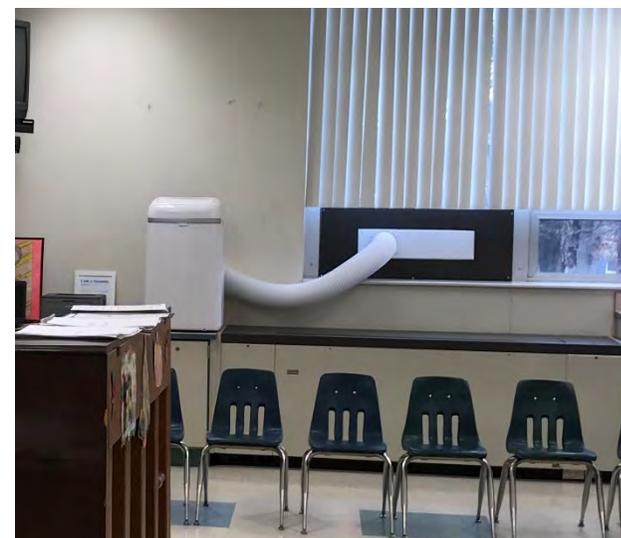
- **Plumbing infrastructure has reached end of functional life**
 - (well water) Booster pumps, water heater, valves, piping, etc.
 - Chlorine feeder, water softening system
 - Water distribution piping is original to the building
 - Sanitary and storm piping is original to the building
 - Secondary (emergency) roof drainage
- **HVAC equipment has reached beyond the end of functional life**
 - Classroom unit ventilators, rooftop equipment, exhaust fans, etc.
 - Pneumatic temperature control system is beyond expected life and difficult to maintain
- **Electrical Equipment has reached end of functional life**
 - Lighting, intercom system, public address system, etc.
 - Fire alarm system is obsolete
 - Data cabling

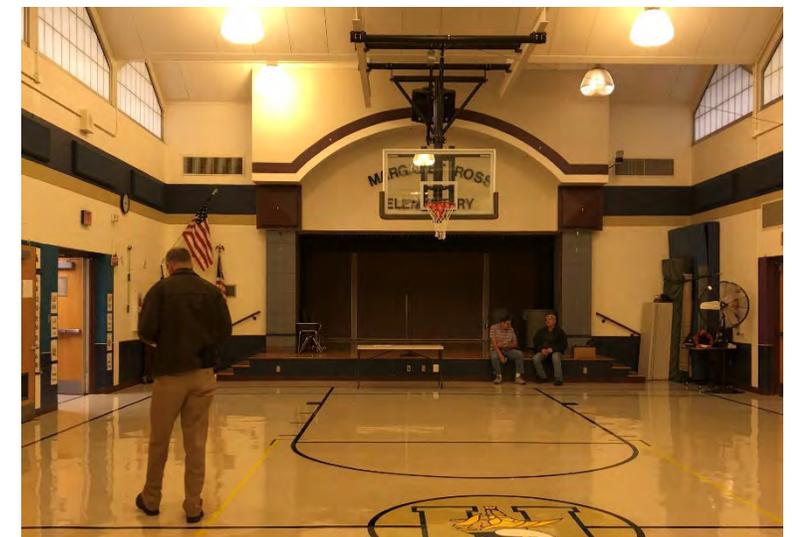
- Replace non-accessible sinks in each classroom, library, nurse, etc.
- Loose equipment stored in corridors
- Non-accessible stage / platform

- Replace exterior hollow metal doors and frames
- Repair portions of roof
- Repair / replace asphalt pavement
- Sidewalk replacement

- Lack of designated hand washing sinks
- Residential microwave in a commercial kitchen

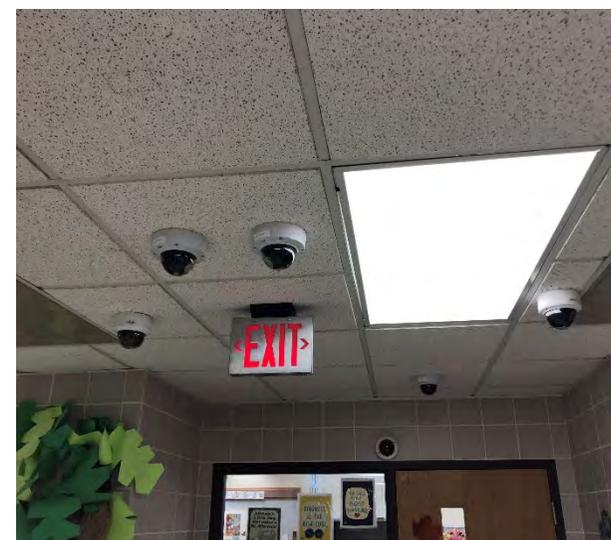
- Water service is fed from bus garage
- **Plumbing infrastructure has reached end of functional life**
 - Water distribution piping, valves, and piping, water softening system, etc.
 - Water heater and related components
 - Sanitary and storm piping is original to the building
 - Secondary (emergency) roof drainage
- **HVAC equipment has reached beyond the end of functional life**
 - Classroom unit ventilators, rooftop equipment, boilers, etc.
 - Pneumatic temperature control system is beyond expected life and difficult to maintain
- **Electrical Equipment has reached end of functional life**
 - Lighting, intercom system, public address system, etc.
 - Fire alarm system is obsolete

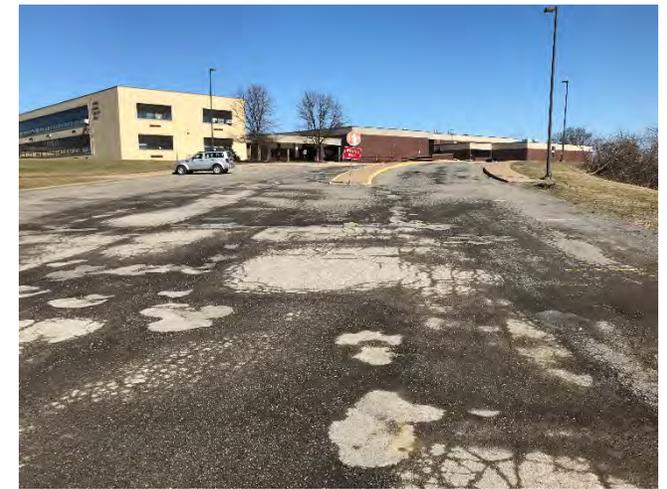
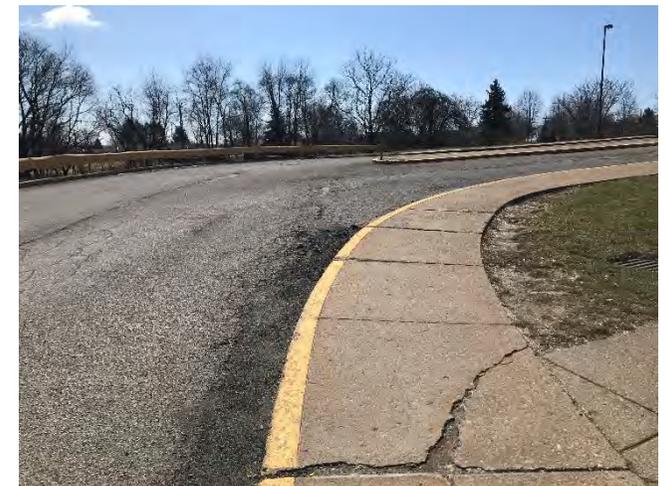
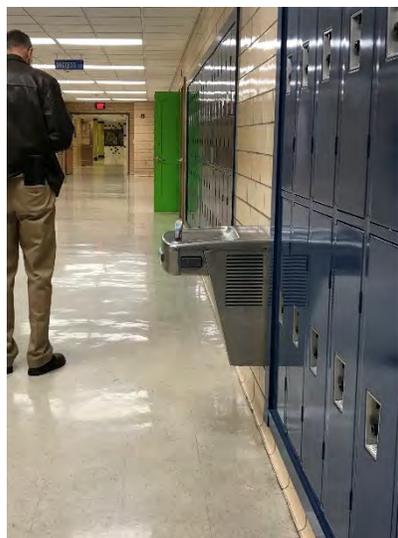
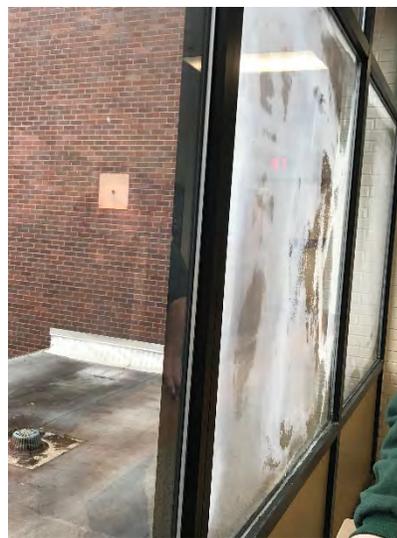
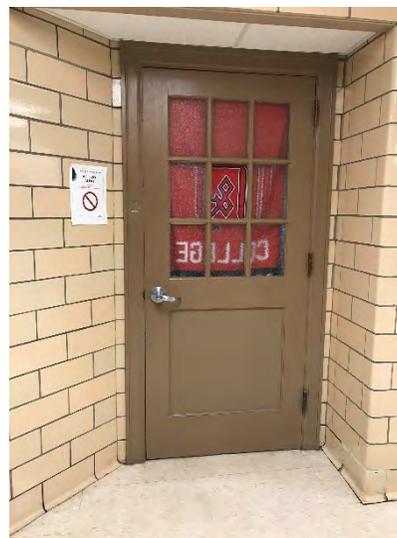
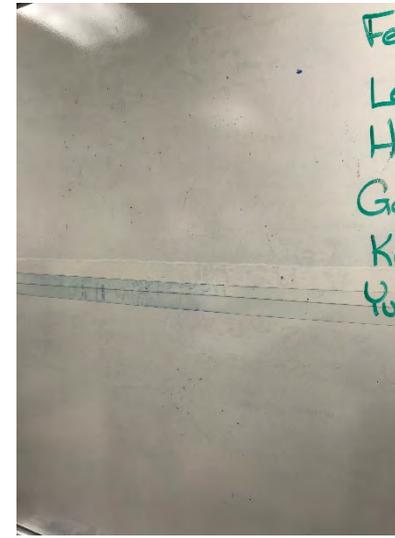
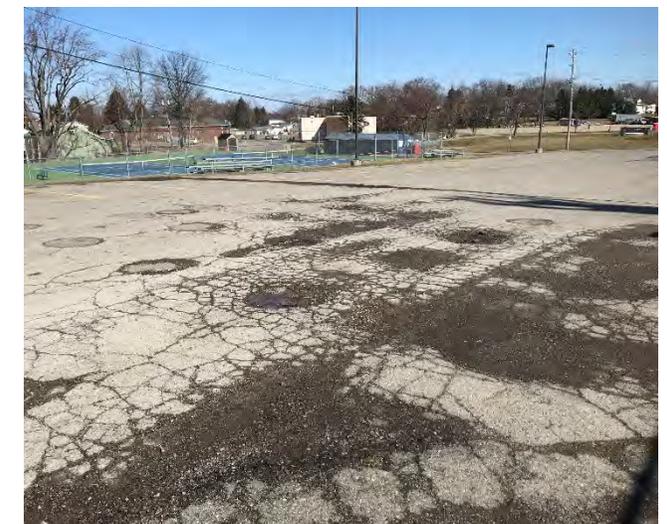
- Replace non-accessible sinks in classrooms, library, nurse, etc.
- Replace non-compliant stair handrails and guardrails
- Loose equipment stored in corridors and stairwells (*reduces egress capacity*)
- Platform (stage) in gym is not accessible

- Replace exterior windows not replaced as part of 2000 renovation
- Replace exterior hollow metal doors and frames
- Complete roof replacement needed
- Replace interior doors not replaced during the 2000 renovation project
- Replace coated / laminated chalk boards
- Repair / replace asphalt pavement (*this work scheduled for Spring 2019*)
- Sidewalk replacement
- "Fault Line" floor settlement around courtyard infill (Library)

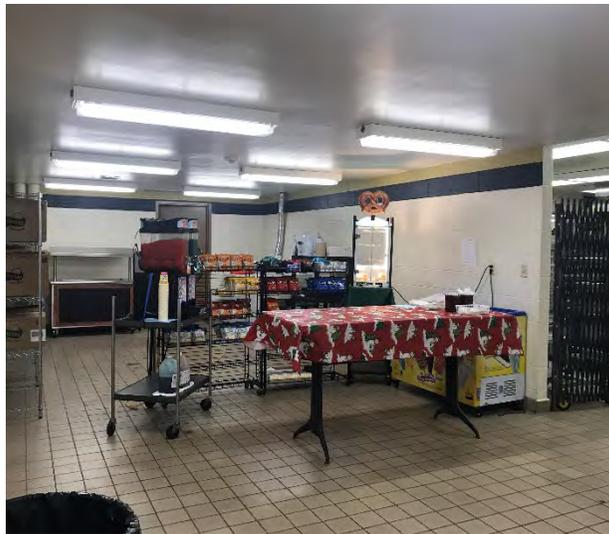
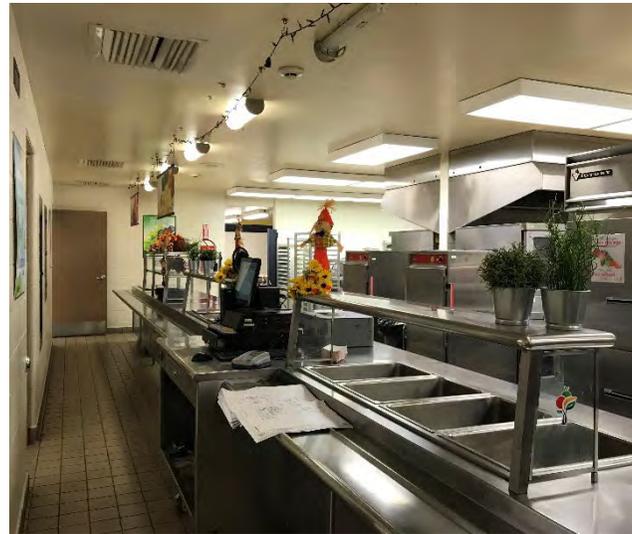
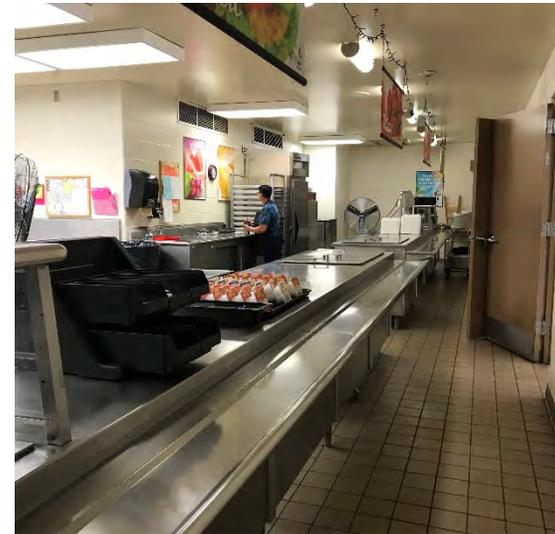
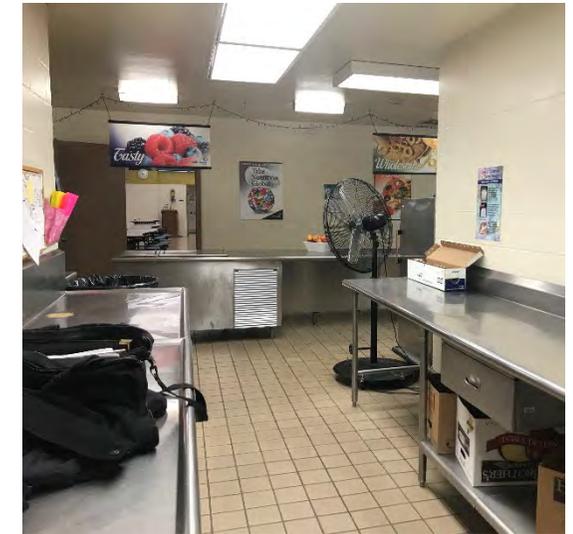
- Last renovation – 40+ years ago
- Make shift “snack room”
- Washer and dryer located within “snack room” (code violation)
- Wood table utilized for slicer (code violation)
- Dated serving configuration for grade level grouping limits menu offerings / revenue
- Many shelving units displaying corrosion
- Lack of dishwashing area
- Lack of designated hand washing sinks

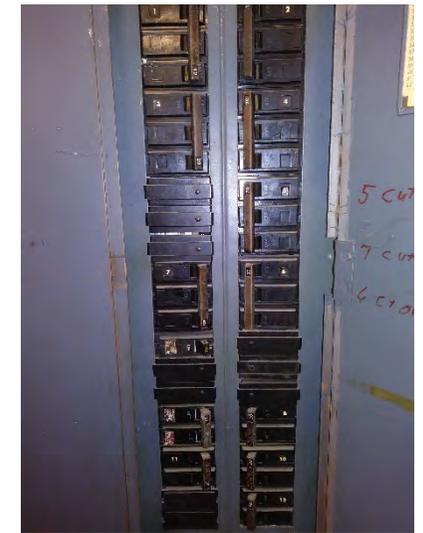
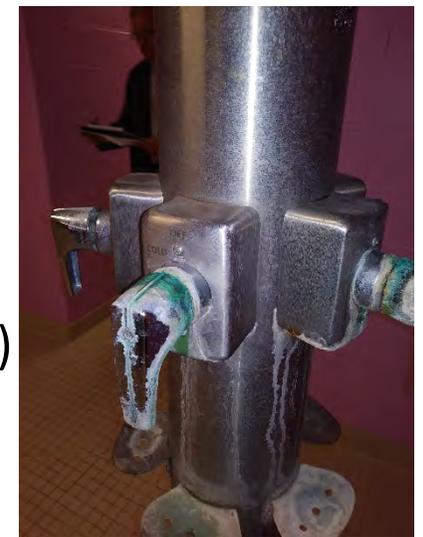
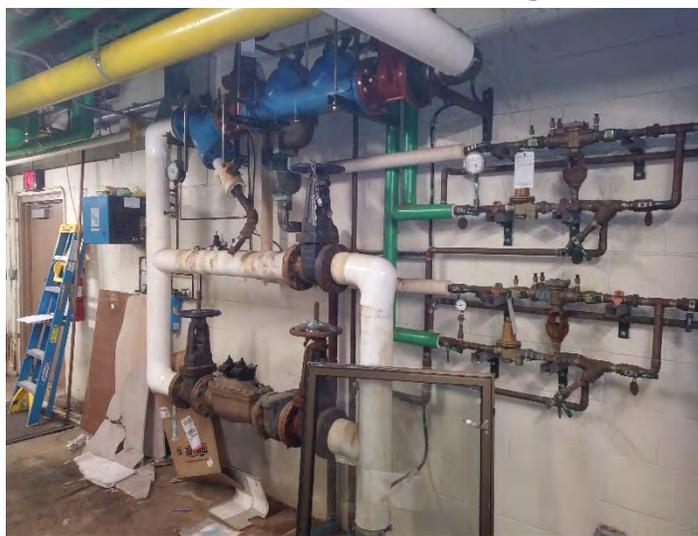
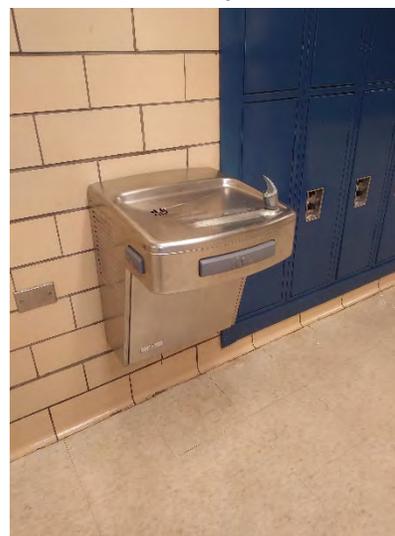
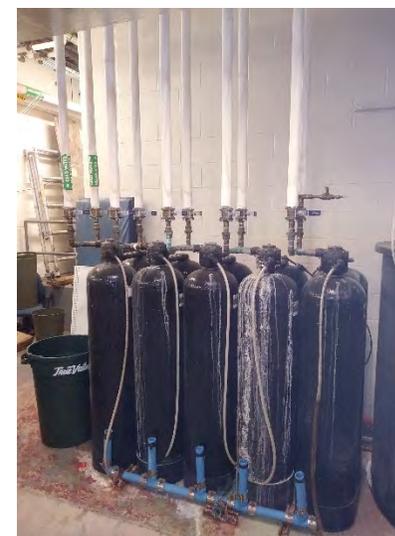
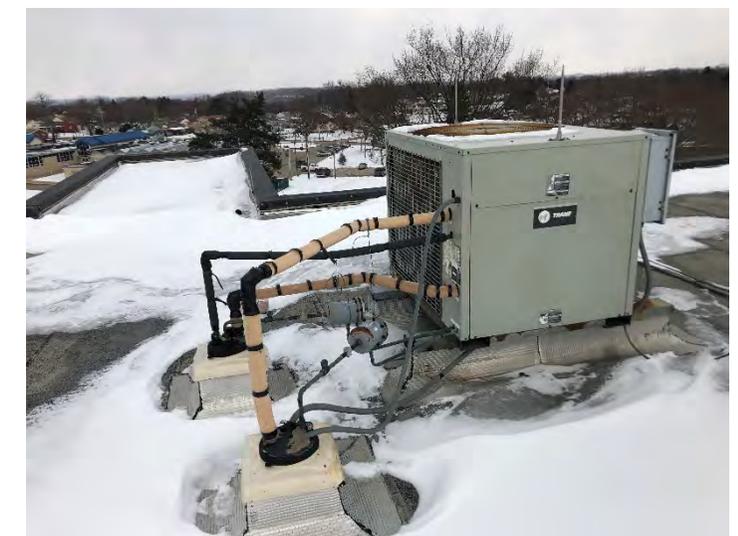
- **Plumbing infrastructure has reached end of functional life**
 - Water service entrance, piping, valves, etc.
 - Water softening system no longer functions

- Water booster pump, water distribution piping, valves, , etc. (low water pressure)
 - Sanitary and storm piping is original to the building (1955)
 - Generator gas line should be separated from the gas line to the building

- Secondary (emergency) roof drainage
- **HVAC equipment has reached beyond the end of functional life**
 - Classroom unit ventilators, rooftop equipment, boilers, etc.

- Pneumatic temperature control system is beyond expected life and difficult to maintain
- **Electrical Equipment has reached end of functional life**
 - Electrical service not big enough if entire school is to be air conditioned (only partial AC)

- Lighting, intercom system, public address system, etc.
 - Fire alarm system is obsolete
 - Kitchen service original to addition (40+ years)

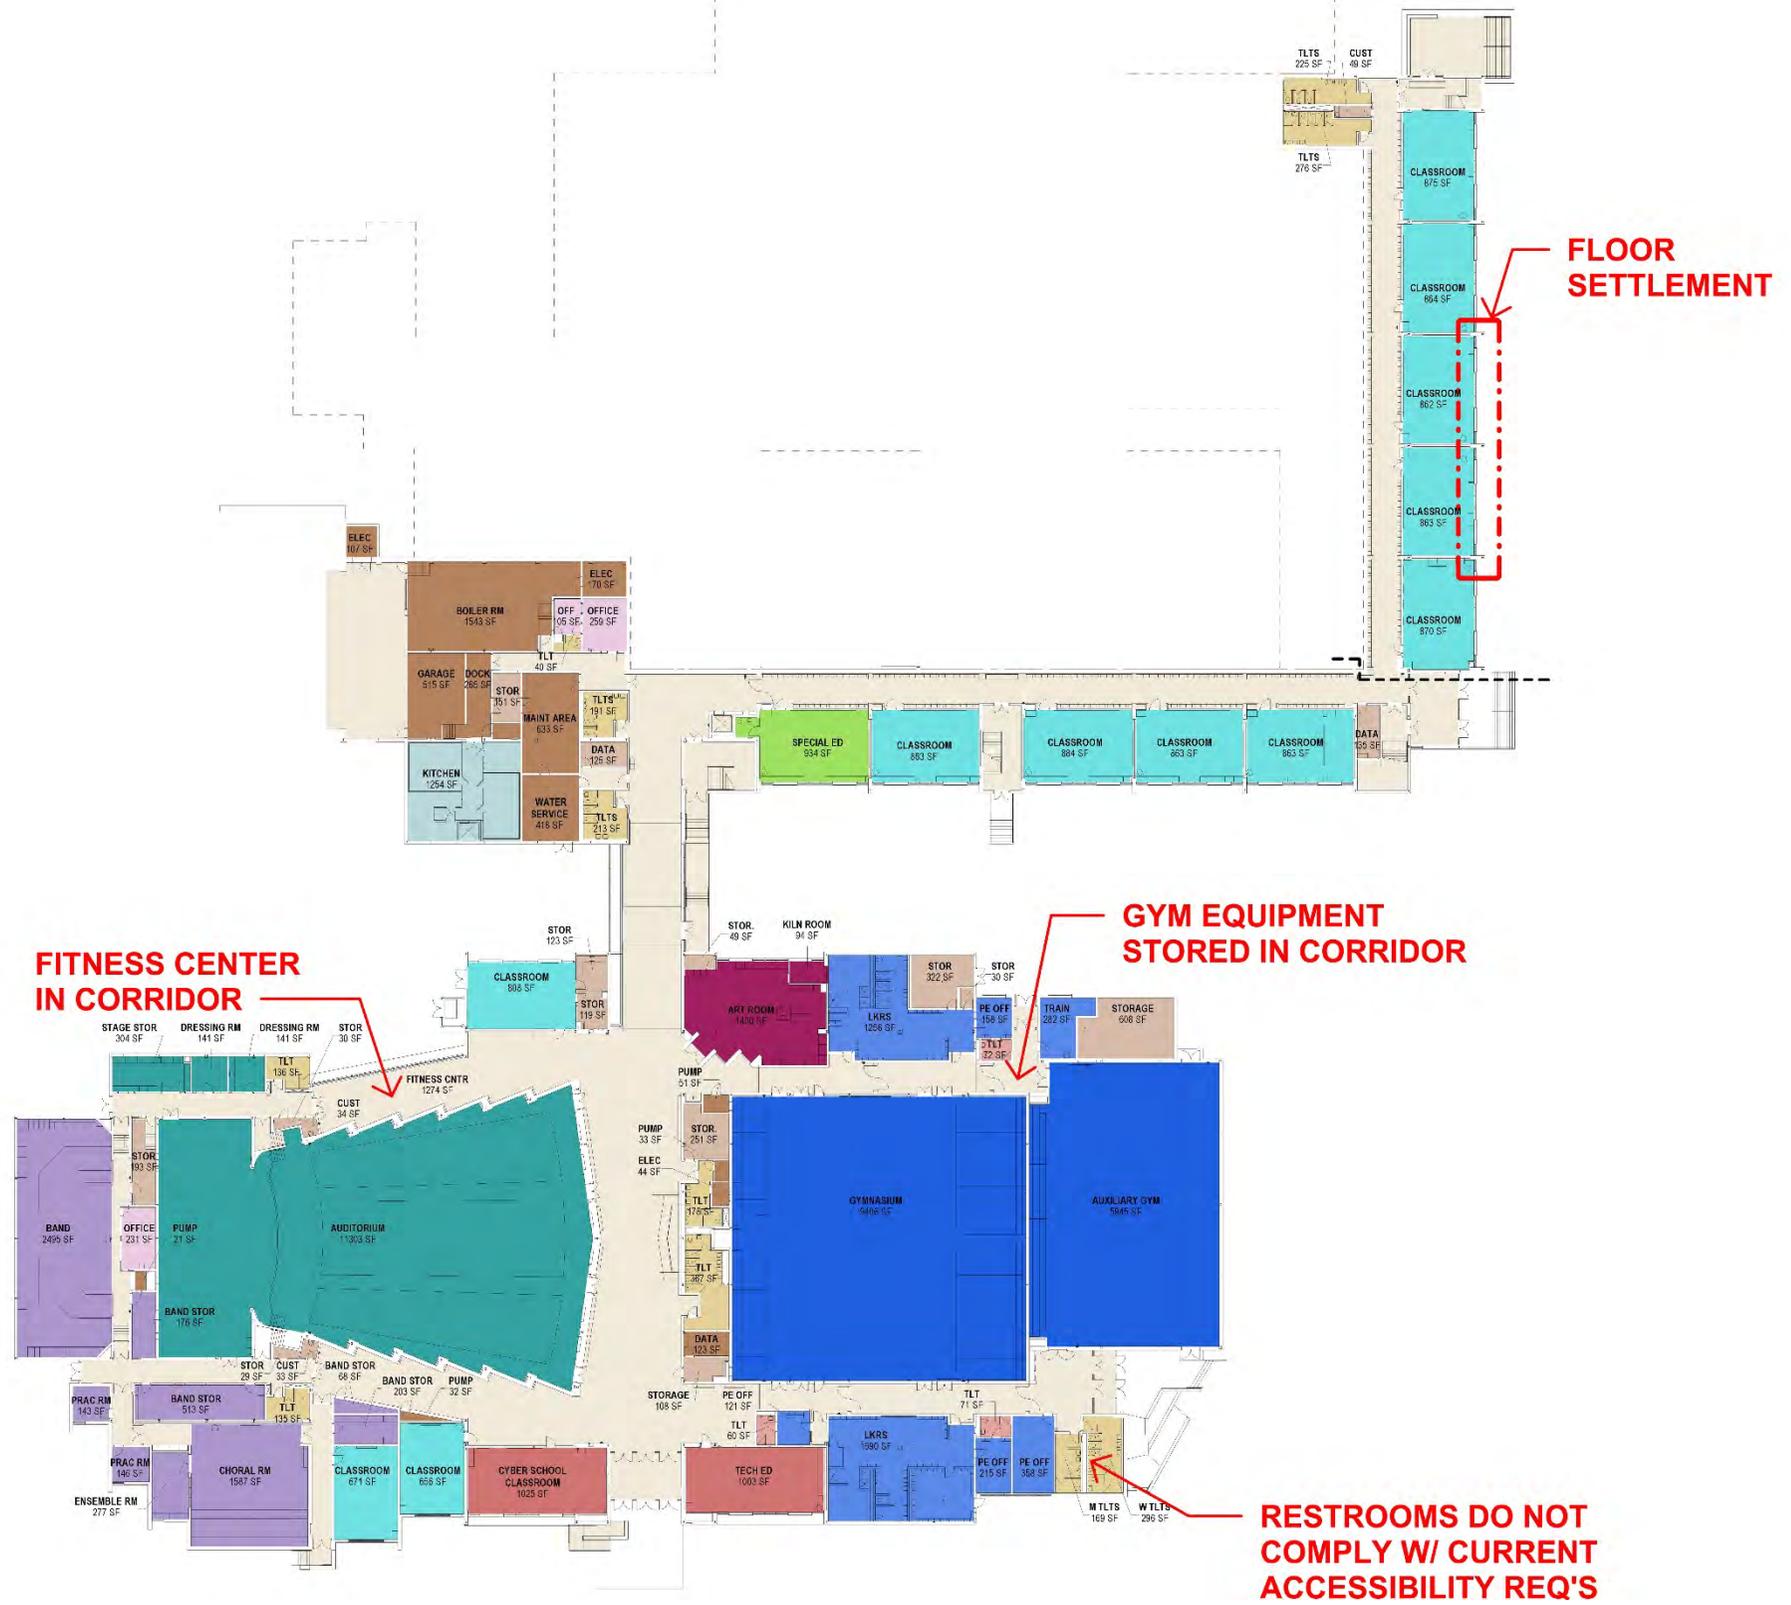
EXISTING BUILDING UTILIZATION – HIGH SCHOOL

**FITNESS CENTER
IN CORRIDOR**

**GYM EQUIPMENT
STORED IN CORRIDOR**

**RESTROOMS DO NOT
COMPLY W/ CURRENT
ACCESSIBILITY REQ'S**

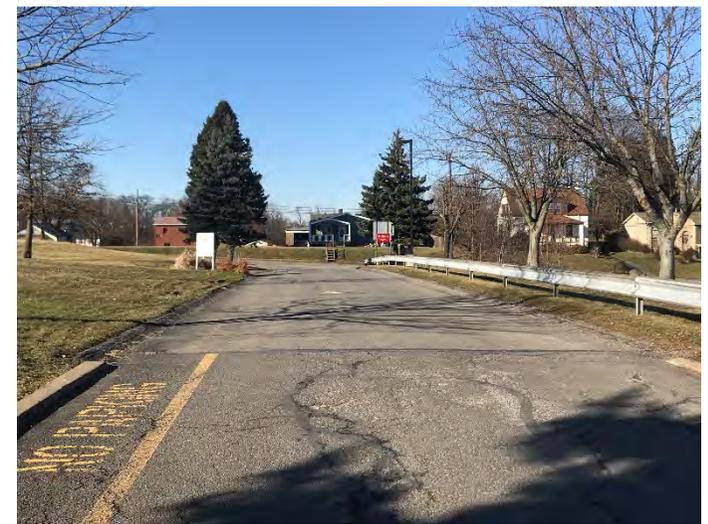
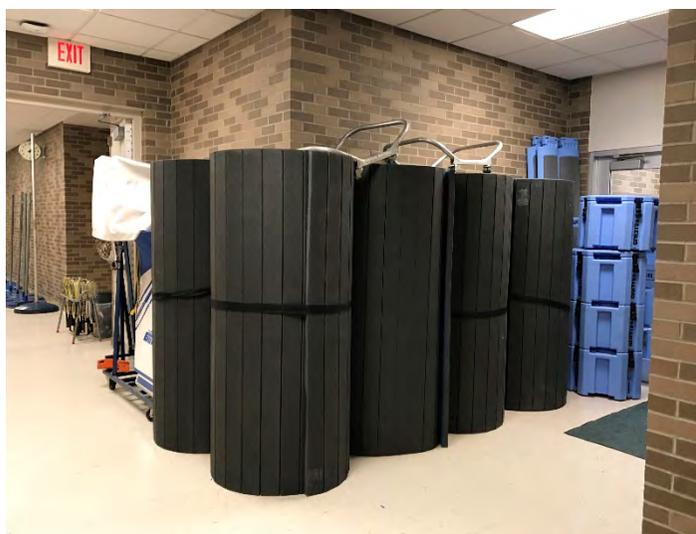
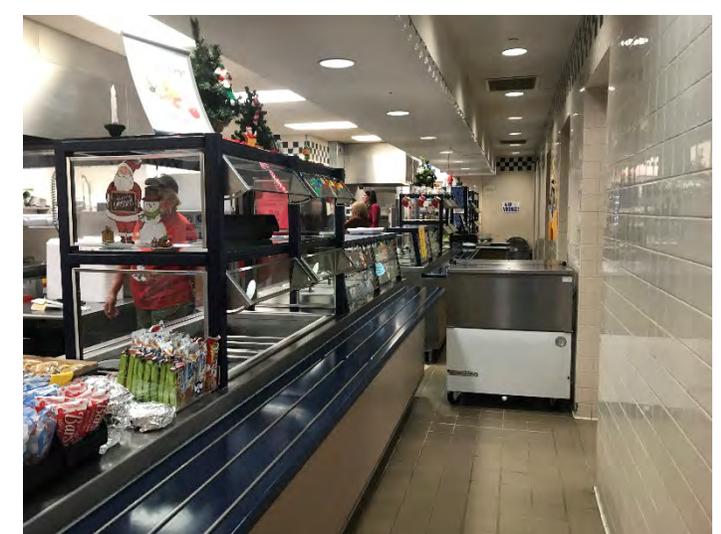
- Auditorium exit door width not compliant
- Dead end corridor in Locker area
- Loose equipment stored in corridors and stairwells (lack of storage)

- Increase loading dock clearance
- Floor settlement in classroom wing
- Partial roof replacement needed
- Repair / replace asphalt pavement in student lot (*this work scheduled for Spring 2019*)
- Partial deteriorated sidewalks

- Undersized kitchen for current student population
- Antiquated serving style limits menu offerings / revenue

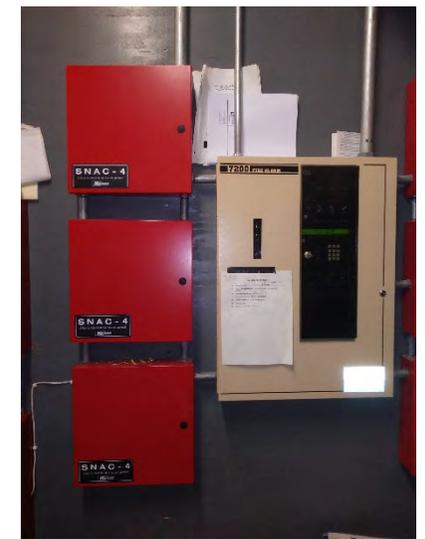
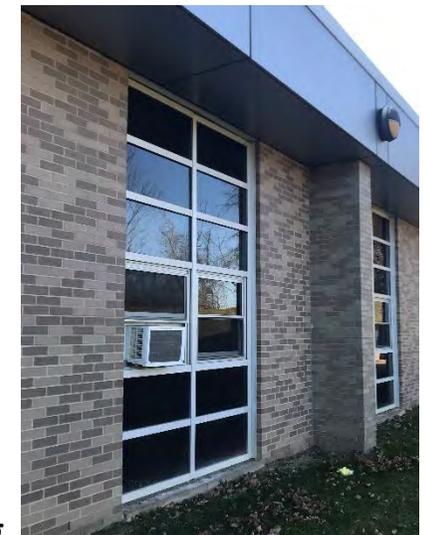
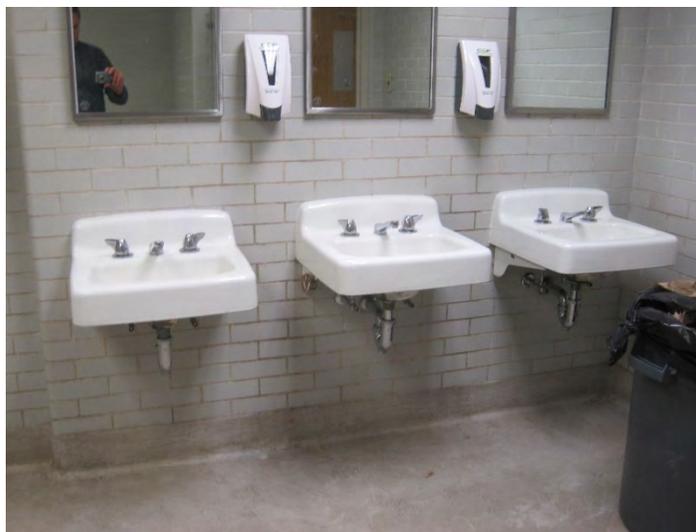
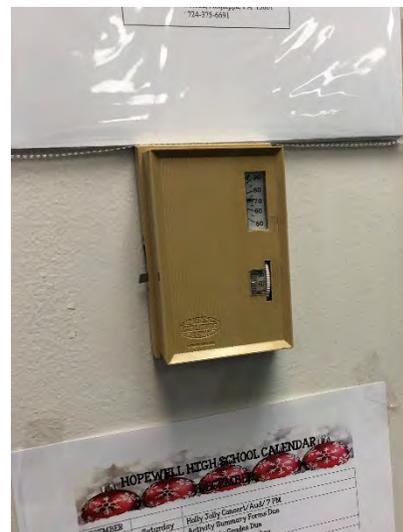
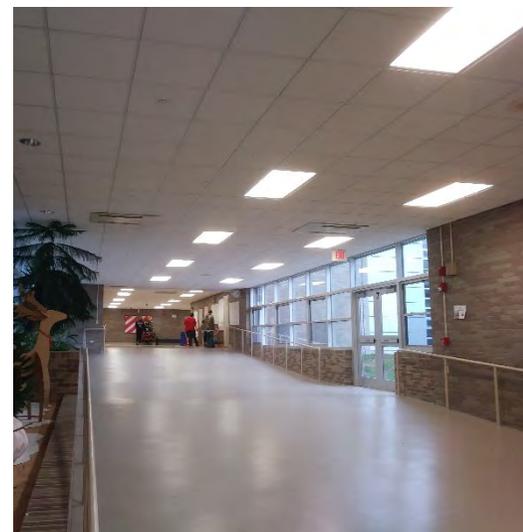
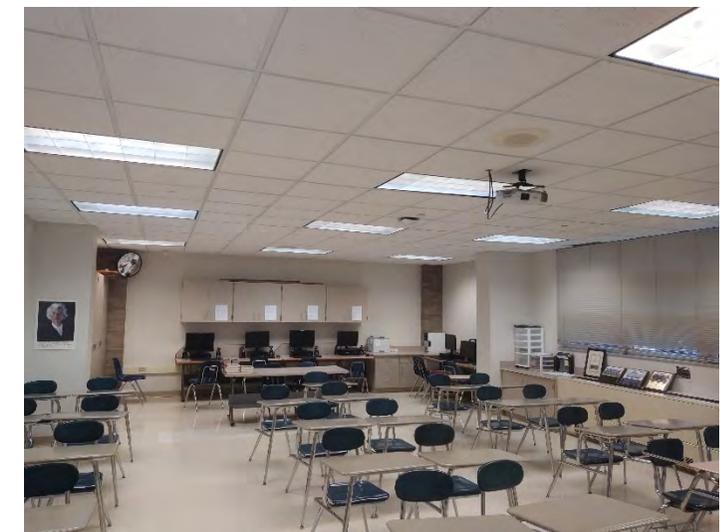
- **Plumbing infrastructure has reached end of functional life**
 - Water service gate valves
 - Water distribution piping throughout is original to the building (1963)

- Sanitary and storm piping is original to the building
 - Hot water storage tank original to the building, no redundancy
 - No thermostatic mixing valves at fixtures, increase circulating water temperature

- Mixing valves needed at safety shower / eye wash stations
- **HVAC equipment has reached beyond the end of functional life**
 - Classroom unit ventilators, rooftop equipment, boilers, etc.

- Pneumatic temperature control system is beyond expected life and difficult to maintain
- **Electrical Equipment has reached end of functional life**
 - Electrical service not big enough if entire school is to be air conditioned (only partial AC)

- Lighting, intercom system, public address system, etc.
 - Fire alarm system is obsolete
 - Multiple receptacles on GFI circuit in Science Labs – circuits lost due to nuisance tripping

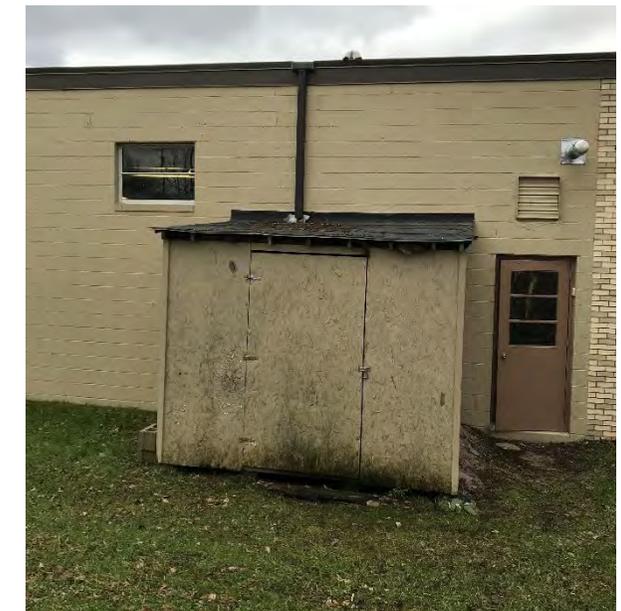
- Congested, lack of privacy for management
- No restroom
- Wood deck / entrance settlement

- No visibility to lot from dispatcher desk
- Small staff lounge, need “kitchen” upgrades
- Garage is not long enough to service bus (*additional 16'-0" needed*)
- Garage does not have lift (*difficult for preventative maintenance servicing*)
- Garage doors have reached end of life
- Water / drainage issues behind building

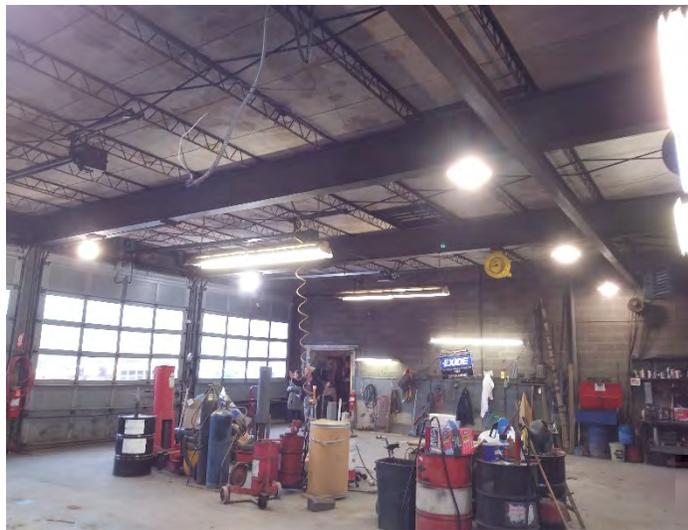
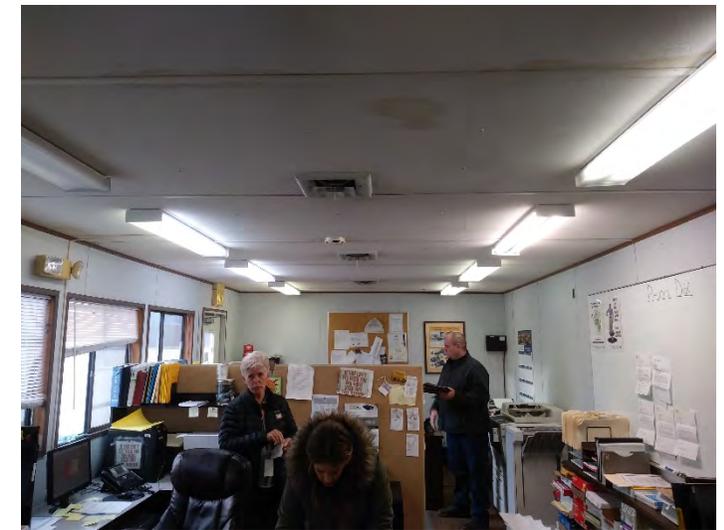
- **Plumbing infrastructure has reached end of functional life**
 - Water service gate valves
 - Water distribution piping throughout is original to the building (*approx. 1960?*)
 - Sanitary and storm piping is original to the building
 - Hot water storage heater original to the building
- **HVAC equipment has reached beyond the end of functional life**
 - Current code requires more mechanical exhaust within garages and garage storage; emissions monitoring is required
- **Electrical Equipment has reached end of functional life**
 - Lighting is 20+ years old
 - Fire alarm system is obsolete
 - Data / network cabling is out in the open and not secure

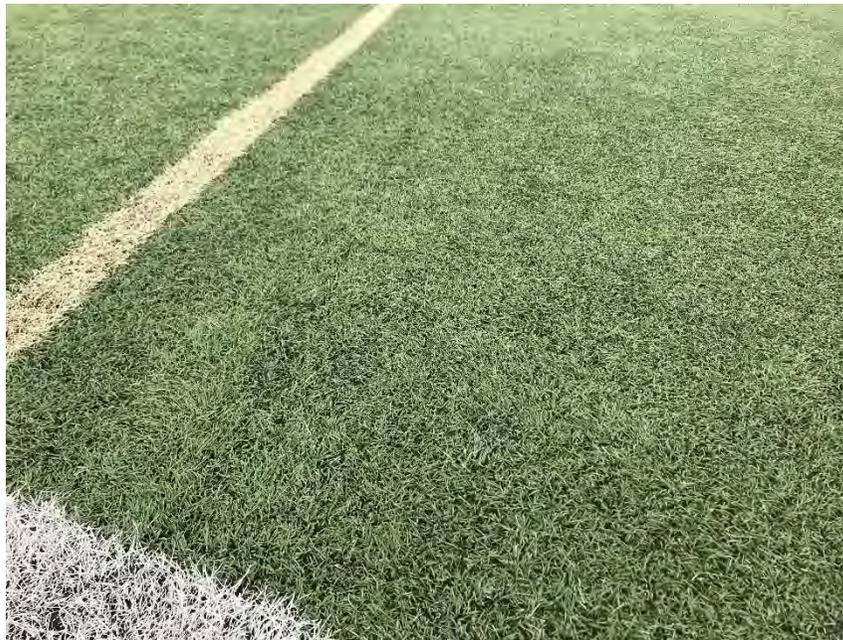
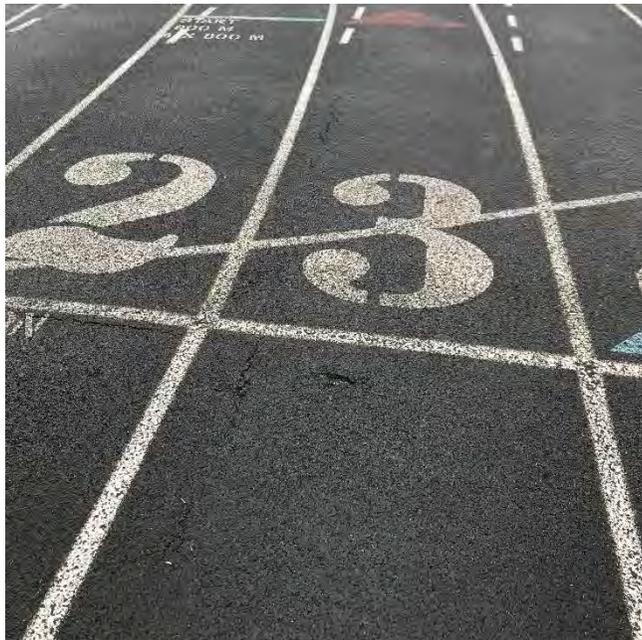
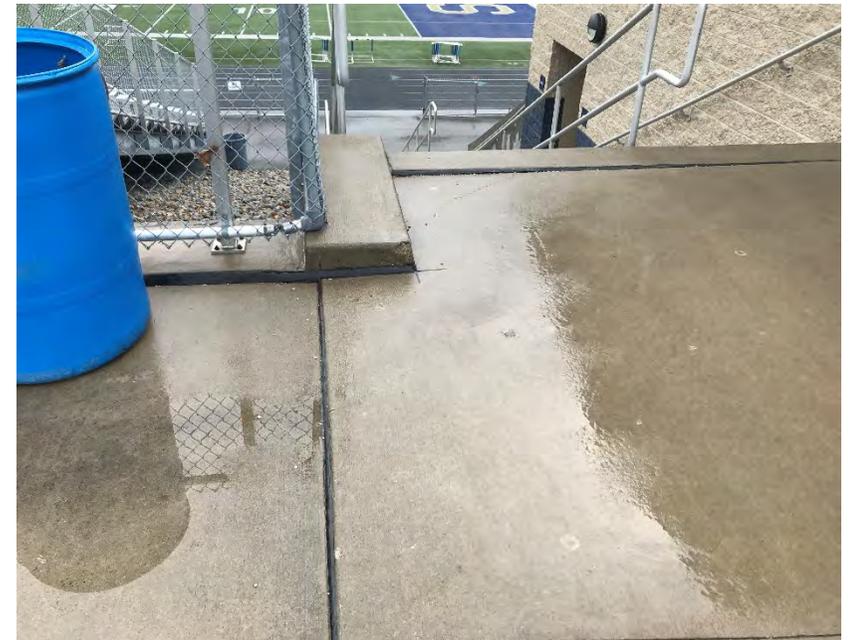
- Artificial field surface is nearing end of life (typical warranty period is 8 years)
- Track subbase is telescoping cracks up to finish surface track surface delamination (repairing as needed)
- Sidewalks have settled over the years (periodic “pumping” has been required)
- Parking lot pavement has deteriorated / underground water concerns
(repavement work scheduled for Spring 2019)
