Hopewell Area School District

Facilities Assessments at:

VEBH Project No. 180700

Preliminary Report (Phase 1) Board Presentation – April 8, 2019

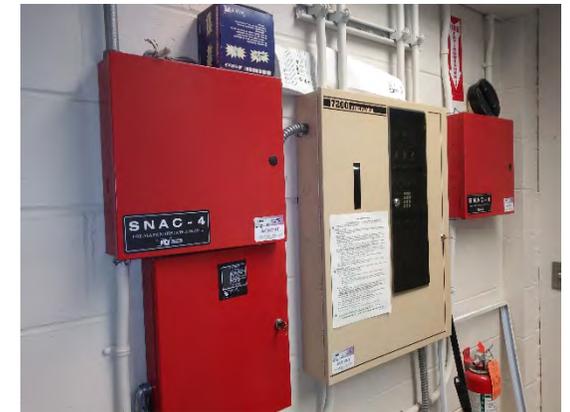
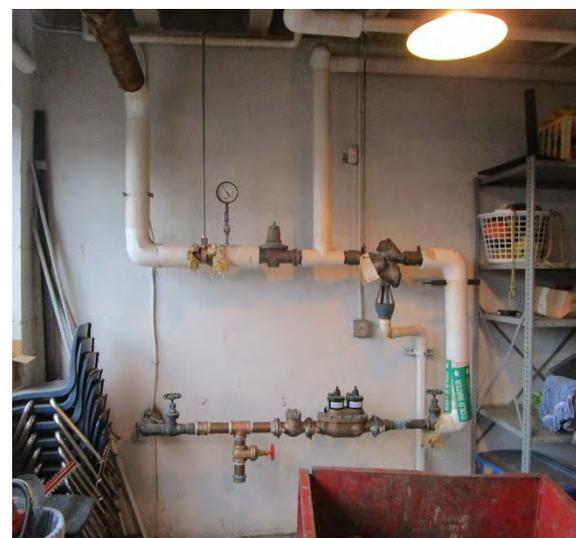
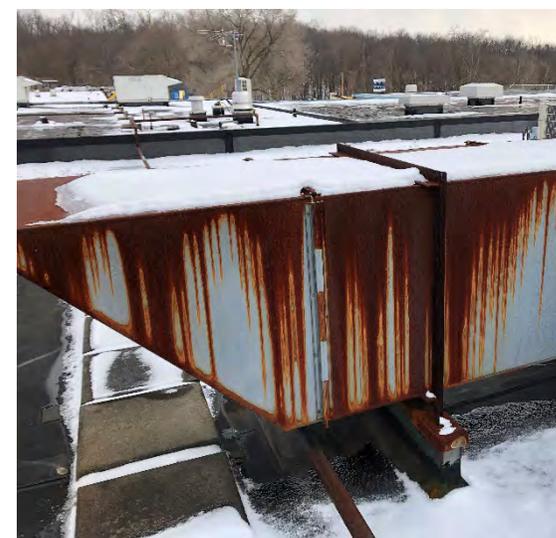
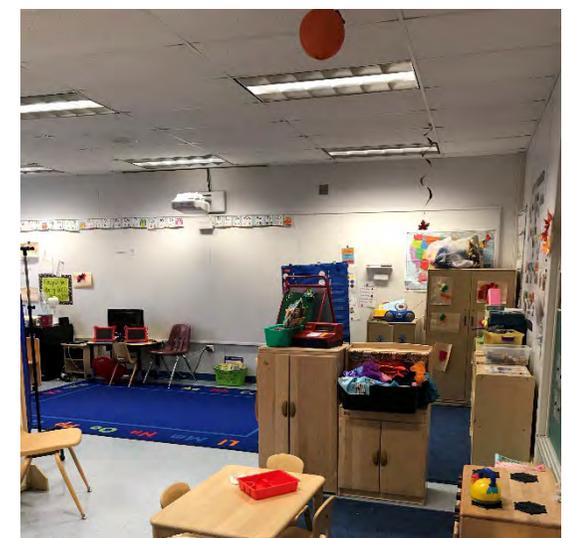
- **Plumbing infrastructure has reached end of functional life**
 - Water service entrance , valves, and piping
 - Water distribution piping is original to the building (*life expectancy is 50 years*)
 - Sanitary and storm piping is original to the building
 - Secondary (emergency) roof drainage
- **HVAC equipment has reached beyond the end of functional life**
 - Classroom unit ventilators, rooftop equipment
 - Pneumatic temperature control system is beyond expected life and difficult to maintain
- **Electrical Equipment has reached end of functional life**
 - Power distribution, lighting, intercom system, public address system, etc.
 - Fire alarm system is obsolete

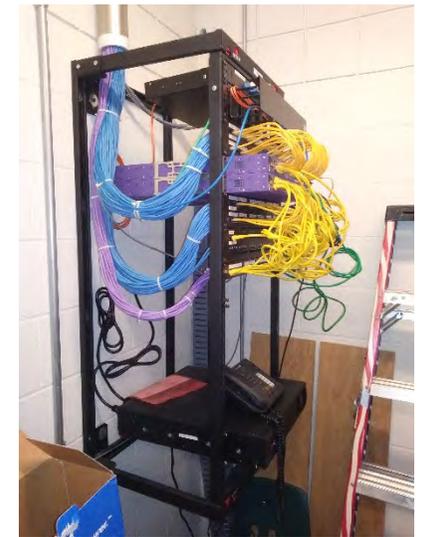
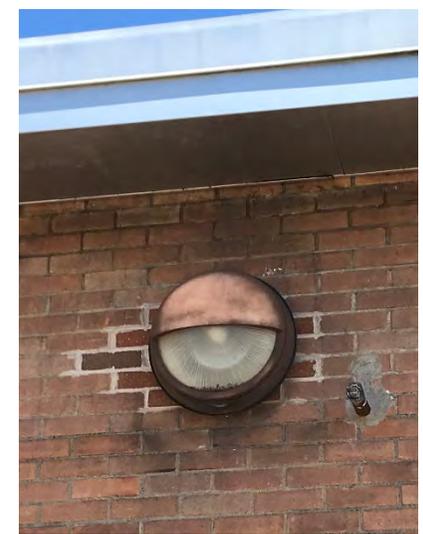
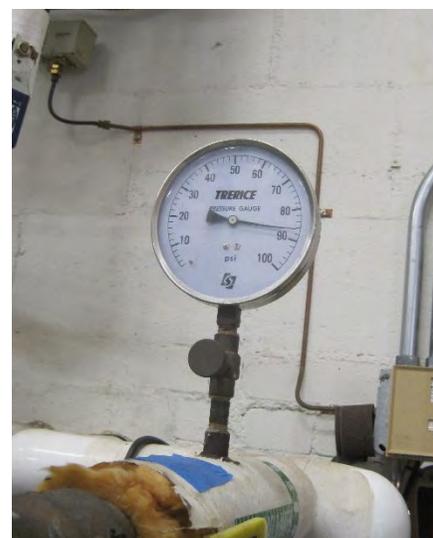
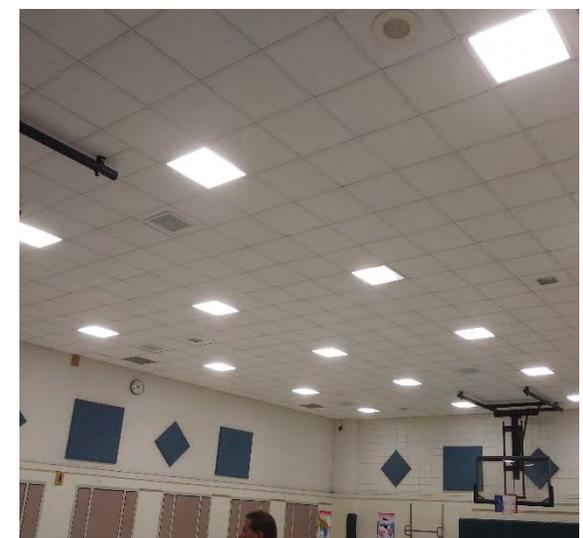
- **Plumbing infrastructure has reached end of functional life**
 - (well water) Booster pumps, water heater, valves, piping, etc.
 - Chlorine feeder, water softening system
 - Water distribution piping is original to the building
 - Sanitary and storm piping is original to the building
 - Secondary (emergency) roof drainage
- **HVAC equipment has reached beyond the end of functional life**
 - Classroom unit ventilators, rooftop equipment, exhaust fans, etc.
 - Pneumatic temperature control system is beyond expected life and difficult to maintain
- **Electrical Equipment has reached end of functional life**
 - Lighting, intercom system, public address system, etc.
 - Fire alarm system is obsolete
 - Data cabling

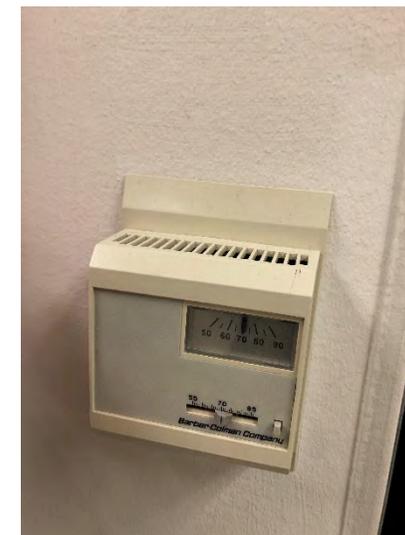
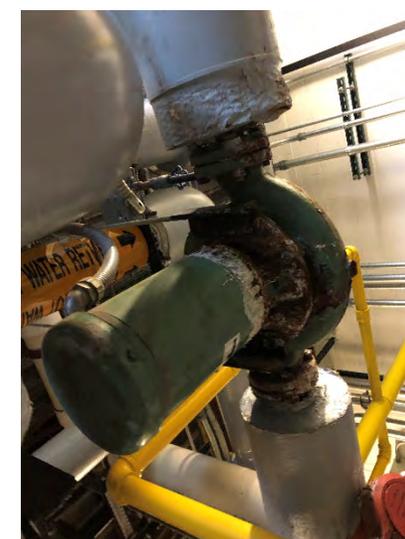
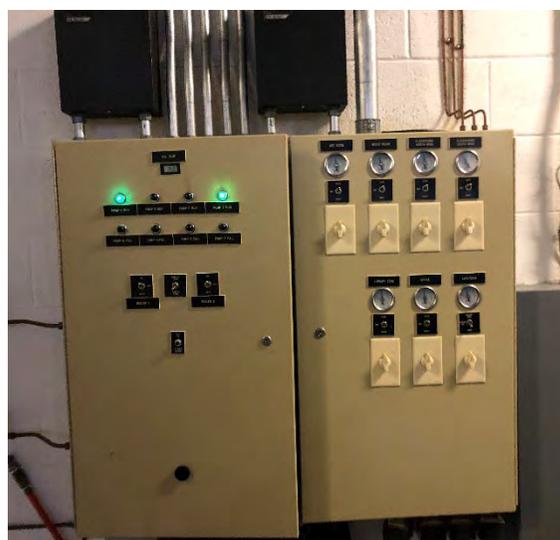
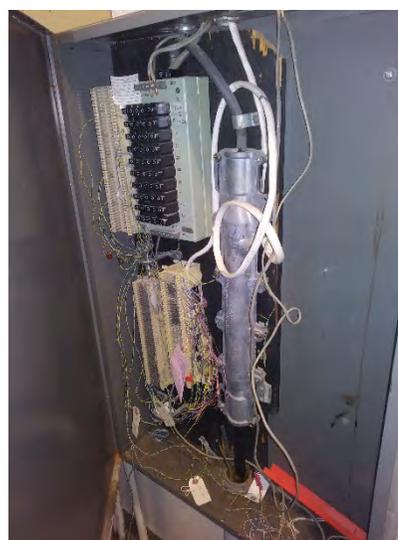
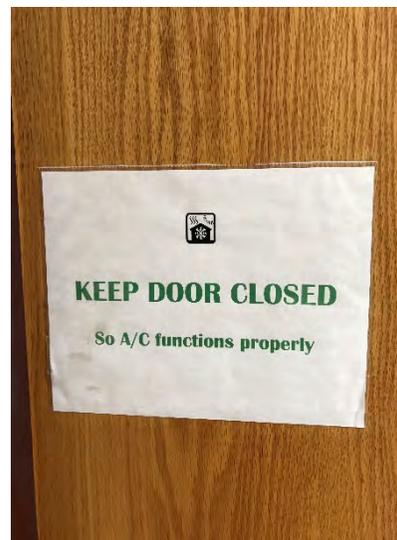
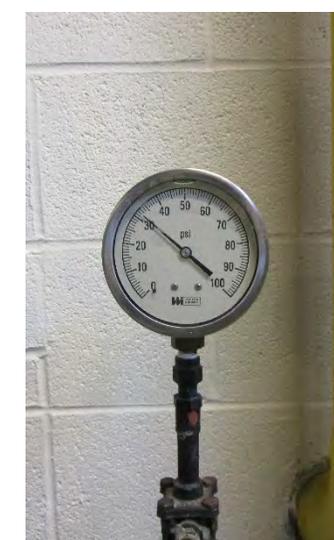
- Water service is fed from bus garage
- **Plumbing infrastructure has reached end of functional life**
 - Water distribution piping, valves, and piping, water softening system, etc.
 - Water heater and related components
 - Sanitary and storm piping is original to the building
 - Secondary (emergency) roof drainage
- **HVAC equipment has reached beyond the end of functional life**
 - Classroom unit ventilators, rooftop equipment, boilers, etc.
 - Pneumatic temperature control system is beyond expected life and difficult to maintain
- **Electrical Equipment has reached end of functional life**
 - Lighting, intercom system, public address system, etc.
 - Fire alarm system is obsolete

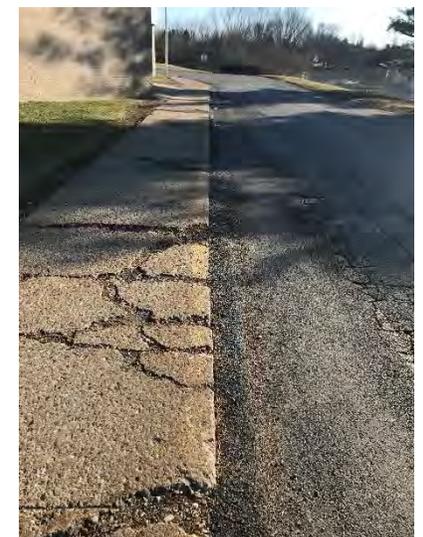
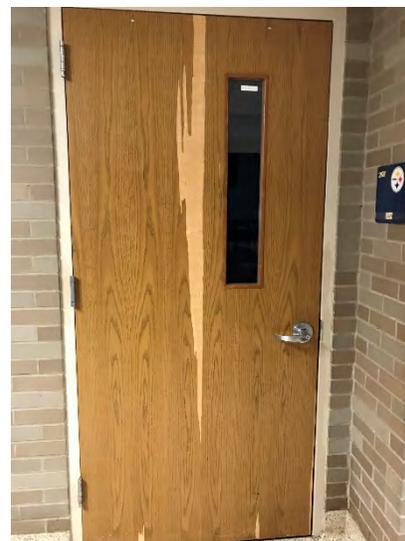
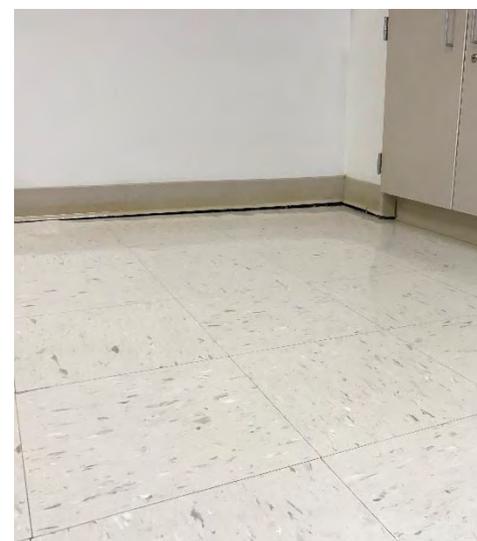
- Increase loading dock clearance
- Floor settlement in classroom wing
- Partial roof replacement needed
- Repair / replace asphalt pavement in student lot (*this work scheduled for Spring 2019*)
- Partial deteriorated sidewalks

Food Service Equipment has reached /exceeded the end of functional life

- Undersized kitchen for current student population
- Antiquated serving style limits menu offerings / revenue

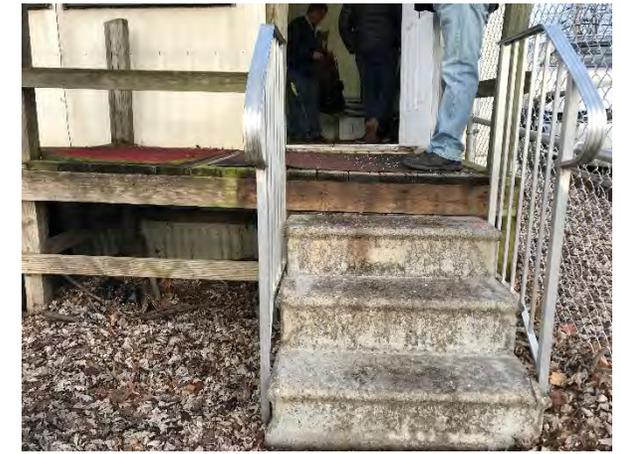
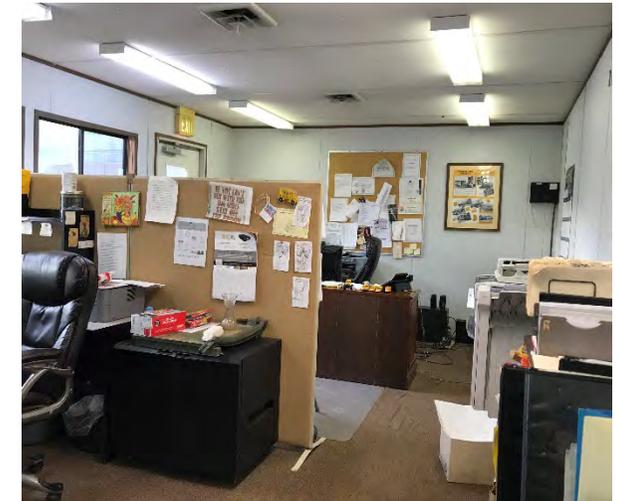
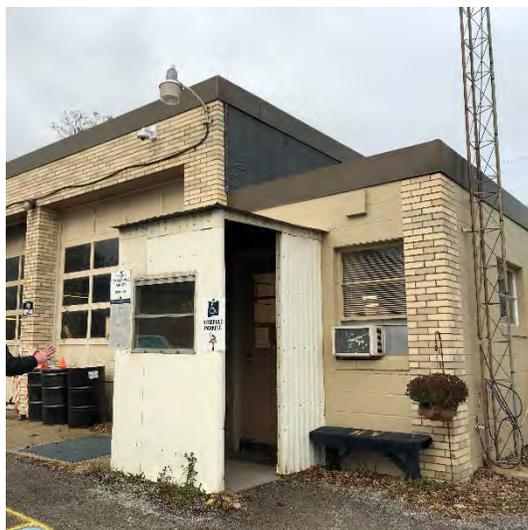
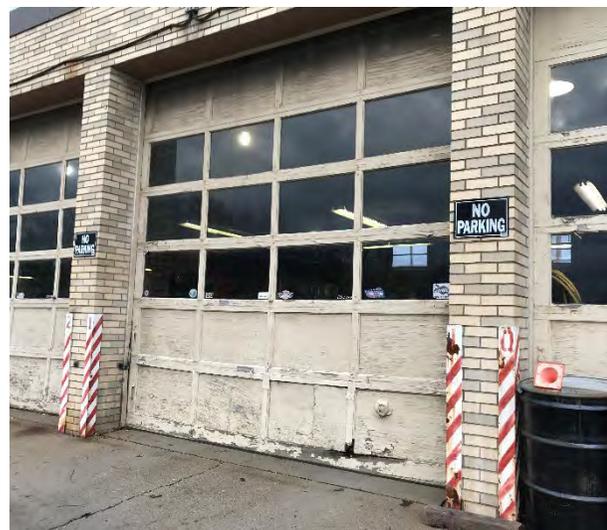
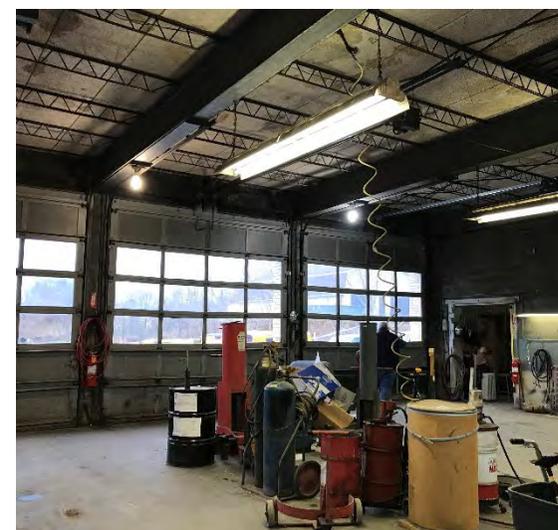
- No visibility to lot from dispatcher desk
- Small staff lounge, need “kitchen” upgrades
- Garage is not long enough to service bus (*additional 16'-0" needed*)
- Garage does not have lift (*difficult for preventative maintenance servicing*)
- Garage doors have reached end of life
- Water / drainage issues behind building

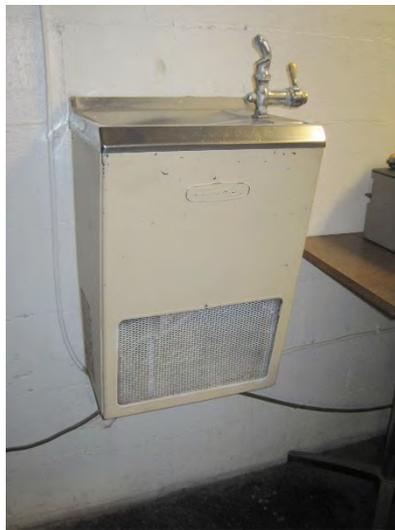
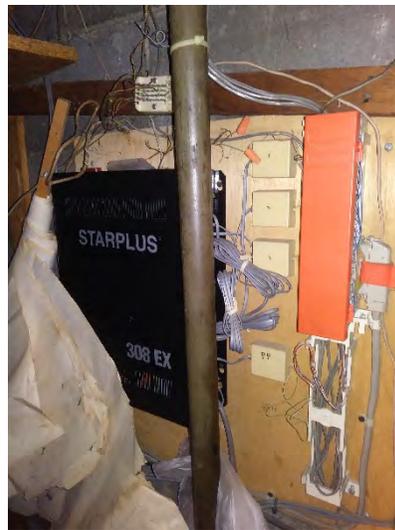
- **Plumbing infrastructure has reached end of functional life**
 - Water service gate valves
 - Water distribution piping throughout is original to the building (*approx. 1960?*)
 - Sanitary and storm piping is original to the building
 - Hot water storage heater original to the building
- **HVAC equipment has reached beyond the end of functional life**
 - Current code requires more mechanical exhaust within garages and garage storage; emissions monitoring is required
- **Electrical Equipment has reached end of functional life**
 - Lighting is 20+ years old
 - Fire alarm system is obsolete
 - Data / network cabling is out in the open and not secure
